Supplemental Report by John W. Carson, Ph.D.

**Failure of a soybean meal silo supplied by Sioux Steel to Agropecuaria
el Avión plant in Tepic, Nayarit, Mexico**

Report 70622-2

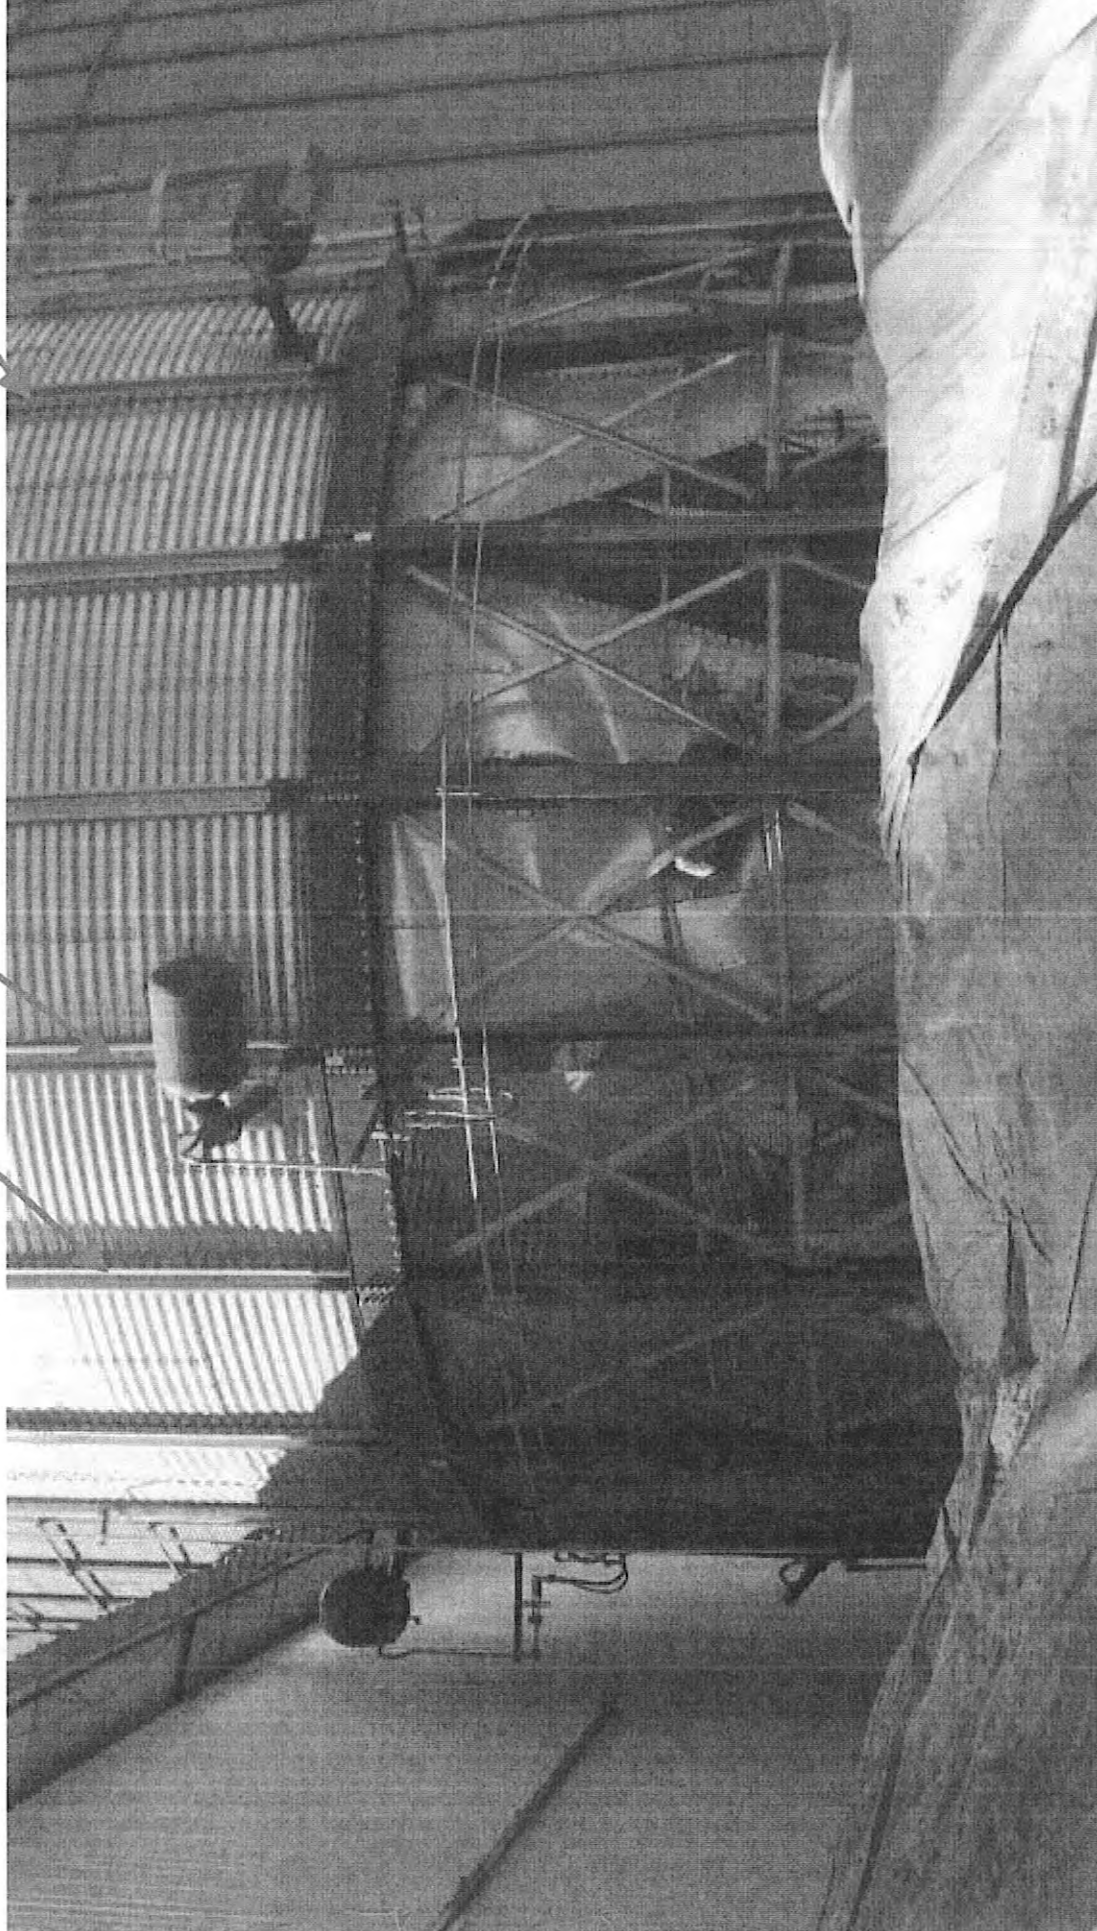
Fig. 1 Photo PLF 624

In reviewing the various photos of the silo after it failed I numbered the seams #1 through 20 starting with the seam adjacent to the cylinder air cannon on the northeast side as #1 and proceeding counterclockwise when looking down on the silo. Using this numbering scheme I was able to identify the first failed seam as seam #4 and the second as seam #20. See Figures 1 and 2.

1. The silo started to fail in the lower portion of one of the northwest hopper seams, most likely what I have denoted as seam #4. Within 0.04 sec. of the start of this failure the upper portion of this seam started to fail. This was followed by failure in the upper portion of one of the northeast seams, most likely what I have denoted as seam #20.

seam #4

seam #1

seam #20

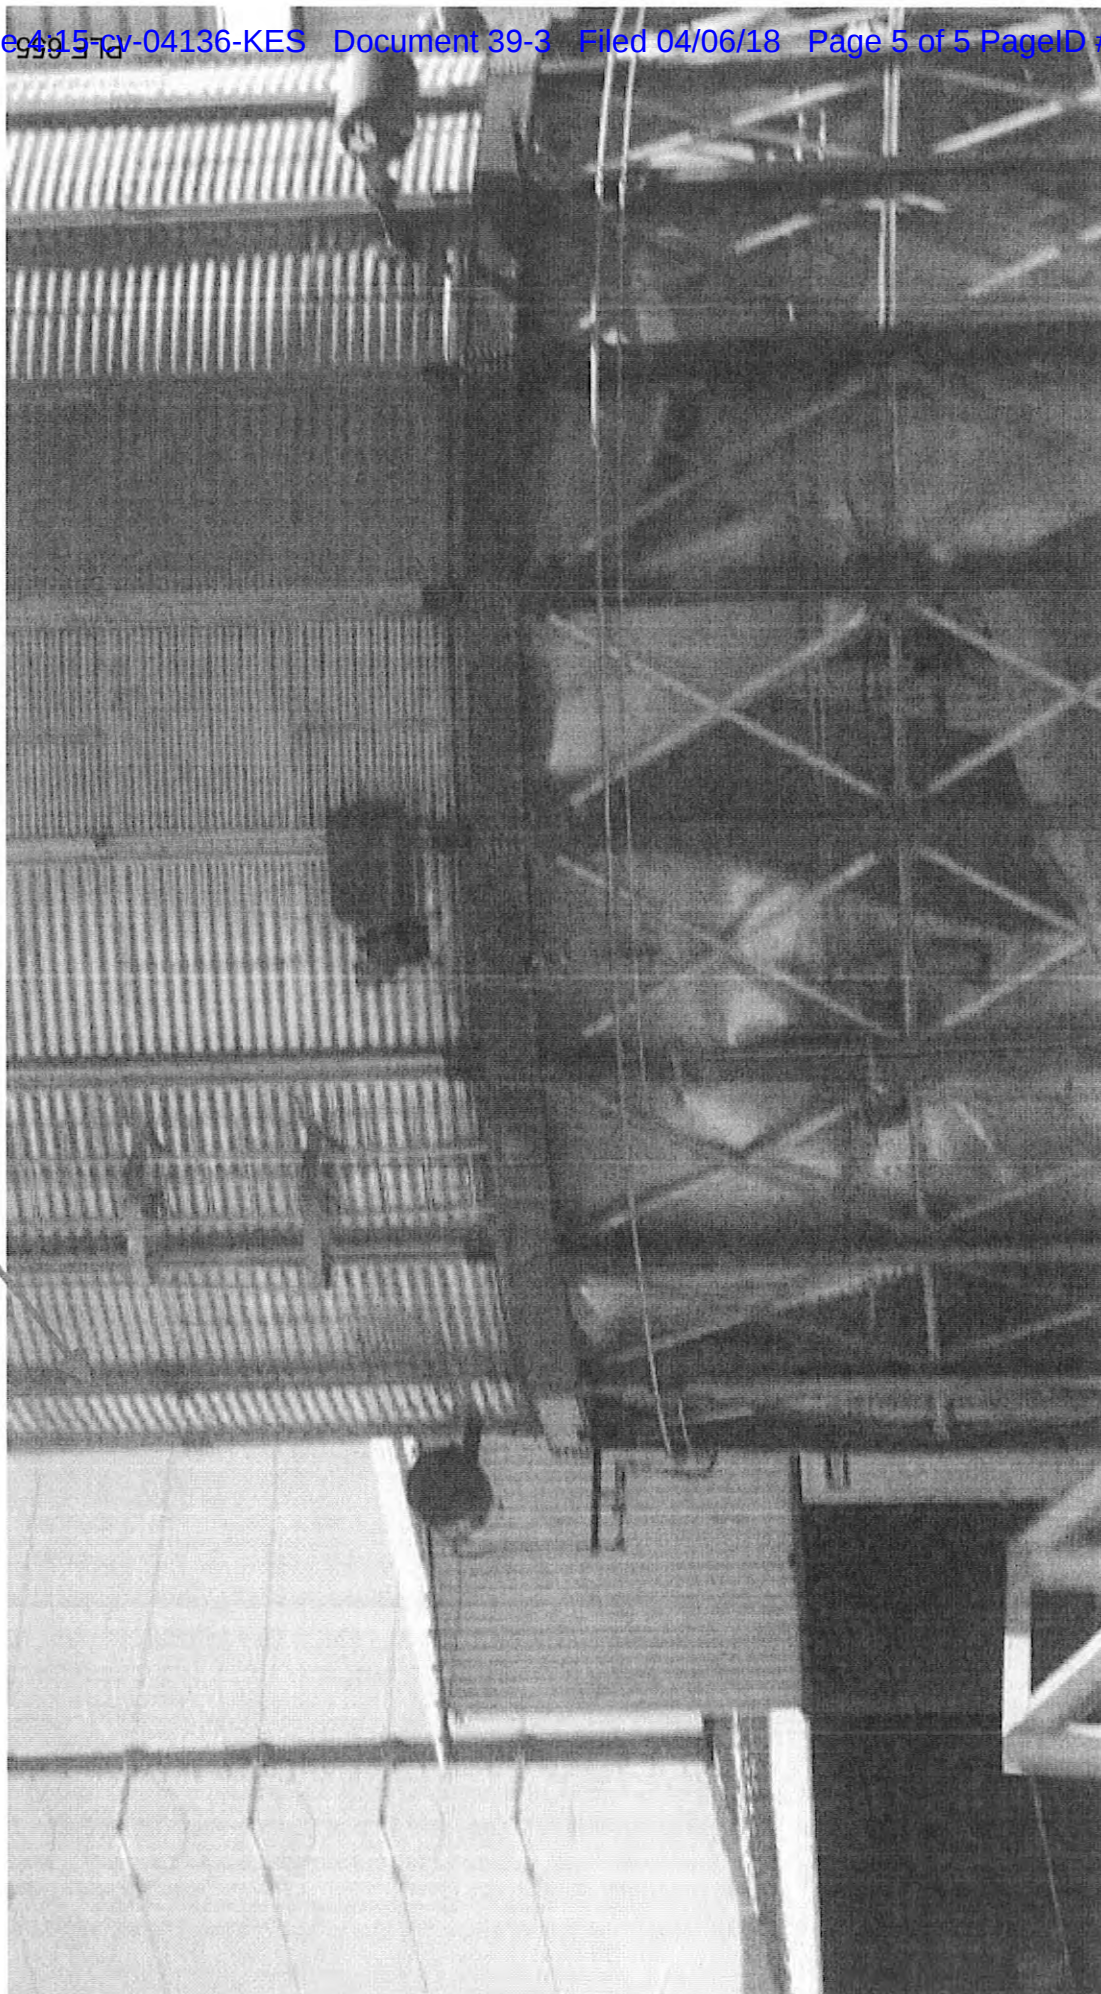
Fig. 2 Photo PLF 655

seam #4
